REAL-TIME CORROSION MONITORING IN A PROCESS STREAM OF A CHEMICAL PLANT USING COUPLED MULTIELECTRODE ARRAY SENSORS

Lietai Yang and Narasi Sridhar
Southwest Research Institute
6220 Culebra Road
San Antonio, TX 78238 USA

Steven L. Grise, Brian J. Saldanha, Michael H. Dorsey,
Heather J. Shore and Amanda L. Smith
DuPont, Wilmington, DE 19898

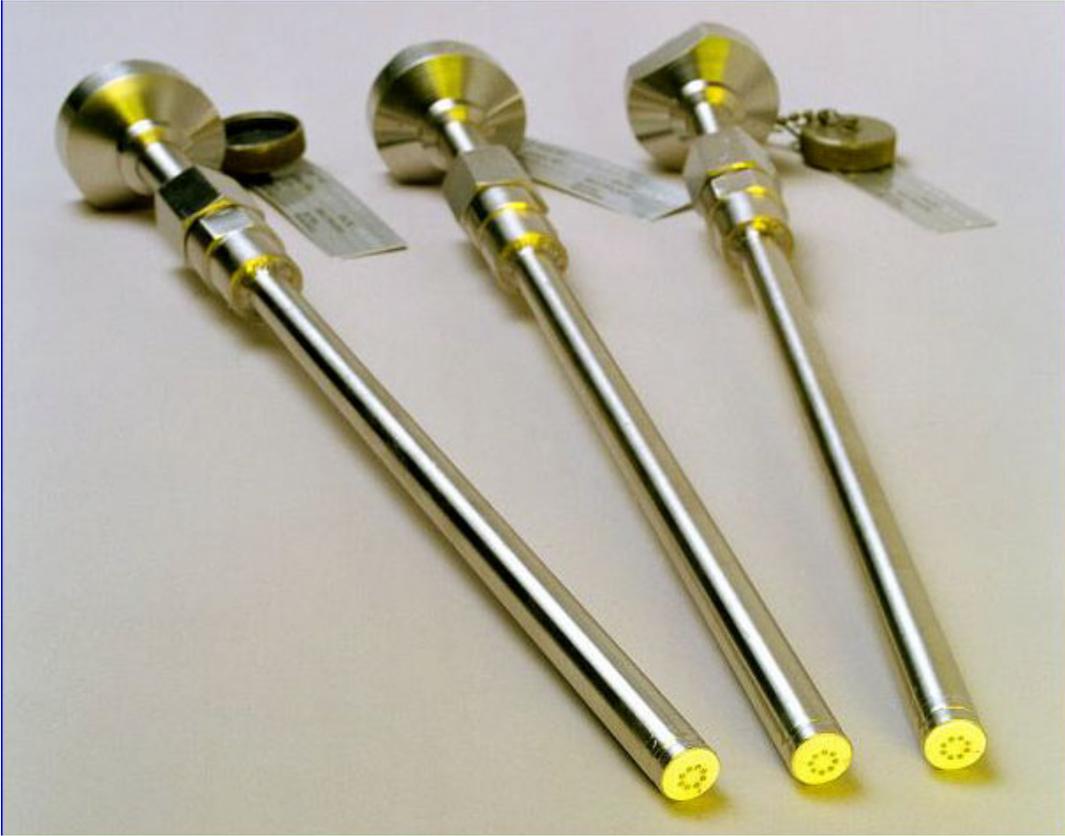
FIGURE 1. Coupled multi-electrode array sensor (MAS) probes for application in a pressurized process stream at elevated temperatures

This technology has been tested extensively for carbon steels, stainless steels, and nickel-based alloys in cooling water, under salt- or bio-deposits, and concentrated chloride solutions³. Three MAS probes were used, each consisting of eight identical solution annealed wires of stainless steel 316L (UNS S31603), AL6XN (UNS N08367) and Alloy C-276 (UNS N10276). The compositions of these alloys are shown in Table 1 and the probes are shown in Figure 1. The probes were designed for applications at pressures as high as 1600 psi (10.88 MPa) and temperatures as high as 230 °C. The tubing material for all the probes was Alloy C-276. The sensing electrodes were flush mounted in Polytetrafluoroethylene (PTFE). The surface area of each electrode in the sensors was 0.00567 cm². Prior to the test, the sensing surfaces of the probes were polished with 600-grit paper and cleaned with acetone.

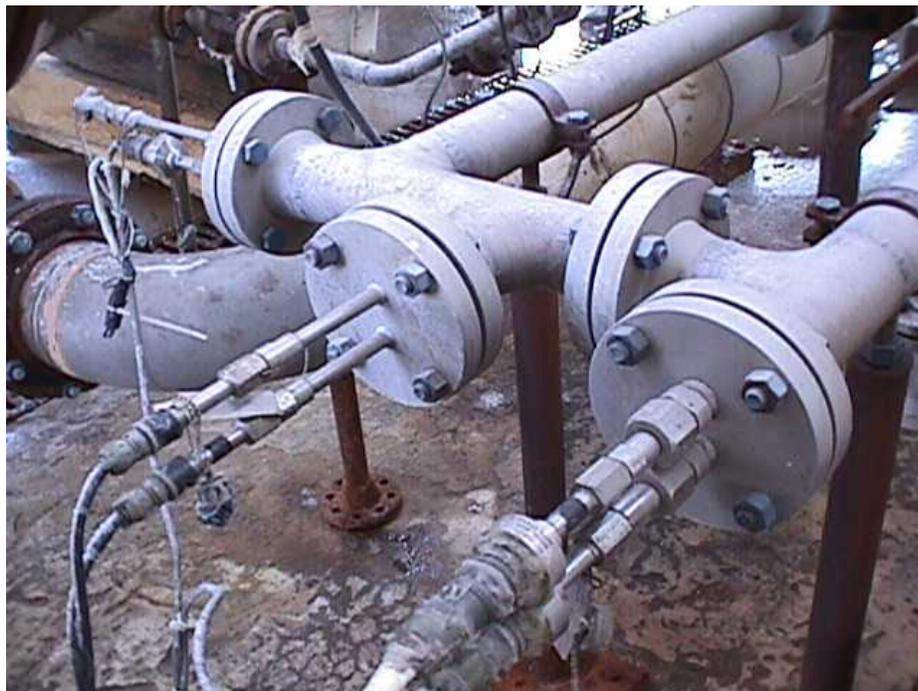
FIGURE 2. Three MAS probes (two on the right flange and one at bottom of left flange) and an external pressure-balanced Ag/AgCl reference probe (at top of left flange) in the side loop of a process stream in a chemical plant. Also shown are standard linear polarization resistance (LPR) probes on the middle flange.

A side loop was constructed out of Alloy C-22 (UNS N06022) into which the MAS probes, Linear Polarization Resistance (LPR) probes, and a high-temperature reference electrode were installed.¹ The reference electrode was an external pressure-balanced Ag/AgCl electrode⁴. The LPR probes were for a different test and their results are not reported in this paper. Figure 2 shows the arrangement of the probes in the pressurized test loop. Data for the MAS probes and electrochemical potentials were collected via a fiber-optic cable in the plant digital control system and downloaded remotely.

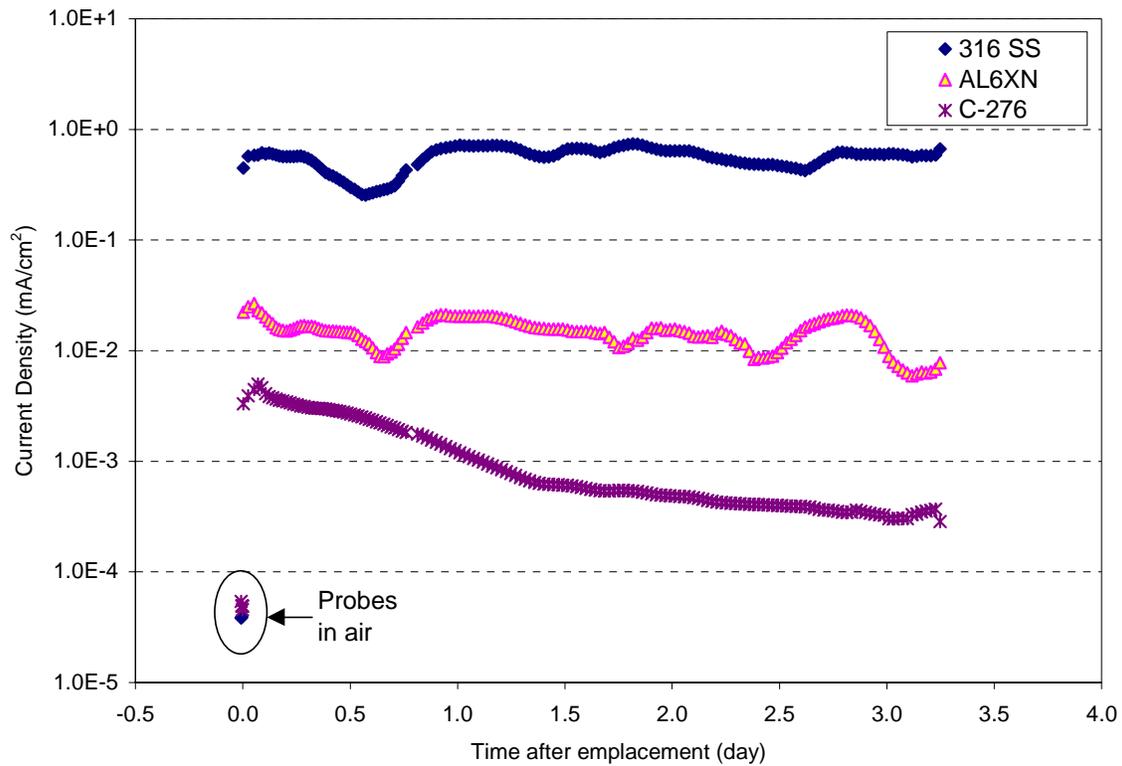
FIGURE 3. Localized corrosion signals from the different probes in a side loop of a pressurized process stream during the initial monitoring periods. At time zero, the probes were exposed to flowing process fluid. The signals measured in air correspond to the background noise, and/or the lower detection limit of the system under the test conditions.

Figure 3 shows the localized corrosion signals (current densities) for the different probes obtained during the initial periods after emplacement. Figure 4 shows the apparent pitting rate obtained by dividing the localized corrosion current signal by the apparent surface area of the electrode². The apparent surface area is the total area exposed to the electrolyte, including the sections that were not corroded. The apparent pitting rate from the Type 316L stainless steel was significantly higher than those from the AL6XN and Alloy C-276 alloys. The apparent pitting rate from the Alloy C-276 probe was the lowest and, in three days, it decreased to 3 μm /year (0.11 mil/year), which is close to the background noise or the lower detection limit of the system under the test conditions (0.45 μm/year or 0.018 mil/year). The variation in the apparent pitting rates from the three probes was more than 3 orders of magnitude.

Figure 5 shows the potentials of the sensors (measured at the joint where all the electrodes were coupled together for each sensor²) and the piping of the side loop. The potentials of Alloy C-276 and AL6XN were significantly more noble than those of the Type 316L stainless steel, indicating that the Type 316L stainless steel was undergoing active corrosion while Alloy C-276 and AL6XN were experiencing passive behavior. In addition, the corrosion potential of the Alloy C-276 probe was, in most cases, higher than that of AL6XN. Therefore, the results in Figure 5 are consistent with those in Figures 3 and 4.

Table 2 presents the values of the calculated PREN or PREN' by weight and by atomic compositions. The relative results as shown in Figures 3, 4 and 5 are in quantitative agreement with the pitting resistance equivalent numbers: 316SS < AL6XN < Alloy C-276.

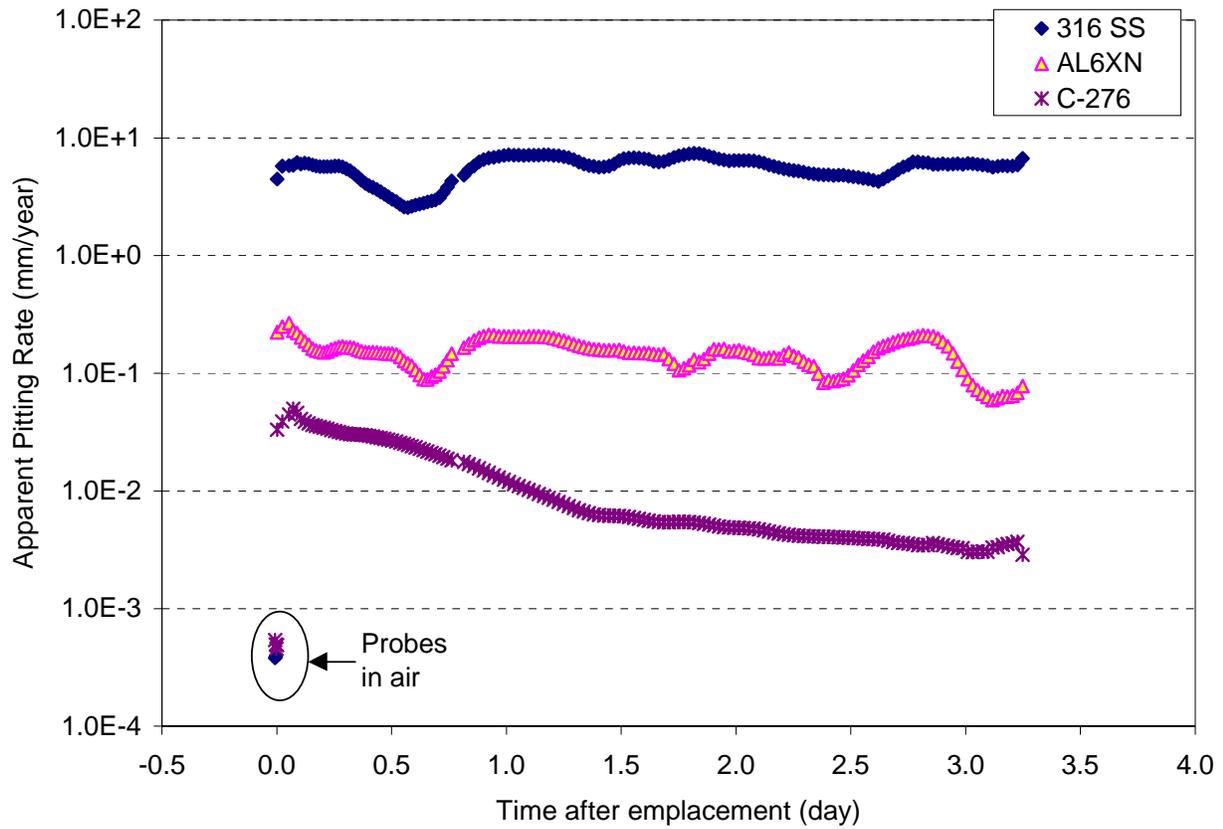
FIGURE 4. Apparent pitting rate from the different probes in a side loop of a pressurized process stream during the initial monitoring periods as indicated in Figure 3.

The results for 316L stainless steel, AL6XN and Alloy C-276 alloys as shown in Figure 4 also agree with the plant experience. Failures have been observed with the Type 316L stainless steel components in the same process stream in the past, and these components have been replaced with more corrosion-resistant alloy metallurgy, such as Alloy C-276, which has performed well in the system for years.

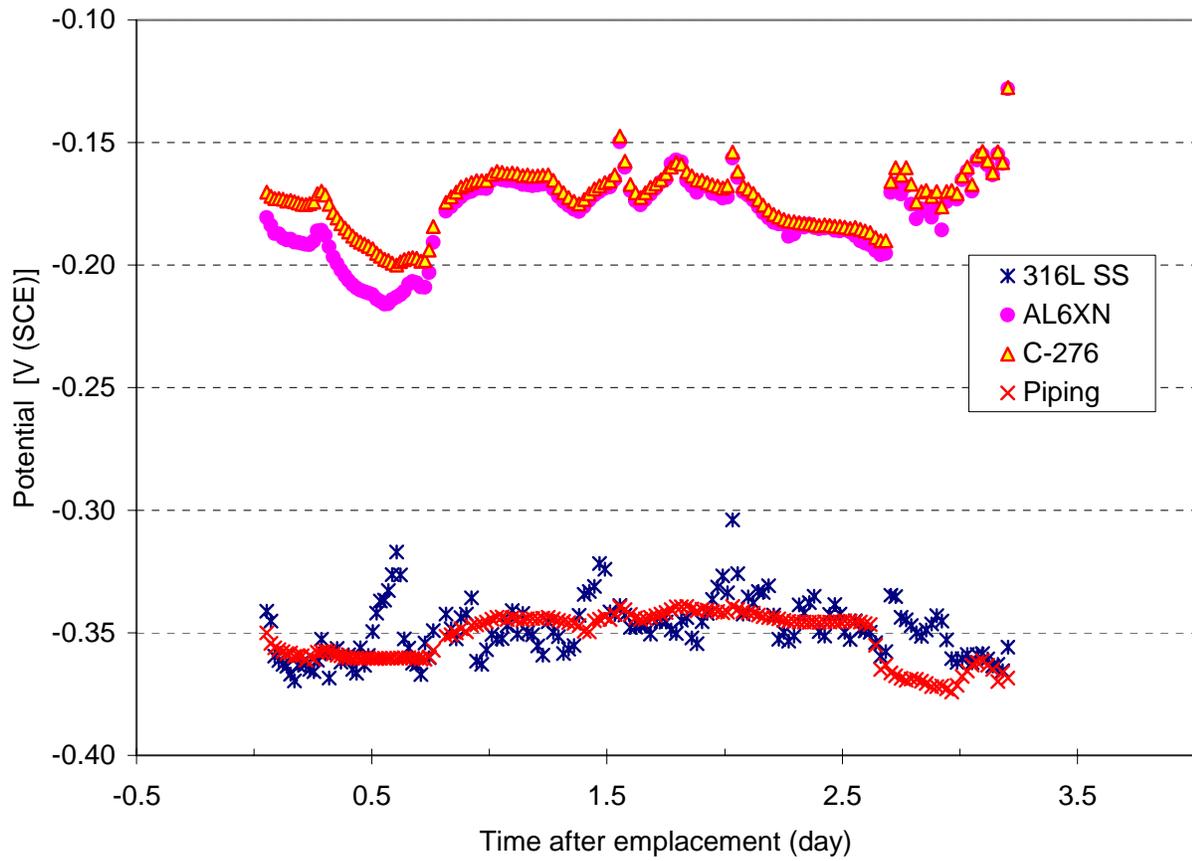
FIGURE 5. Electrochemical potentials of the different probes and the piping of the side loop during the time as shown in Figures 3 and 4.

The potential of the piping of the side loop was low and very close to that of the Type 316L stainless steel probes (Figure 5). This was surprising as the side loop is constructed of Alloy C-22, and its potential would have been expected to be closer to that of Alloy C-276. In addition, inspections of this piping did not indicate any active or localized corrosion. Therefore, the much lower corrosion potential of the piping suggests that there must be some other components of the piping system must be undergoing active corrosion. Apparently, the active material was not the loop itself. As the solution contained a high concentration of salts and was highly conductive, the low corrosion potential may have been a reflection of other more active components even though they might be some distance away from the side loop.

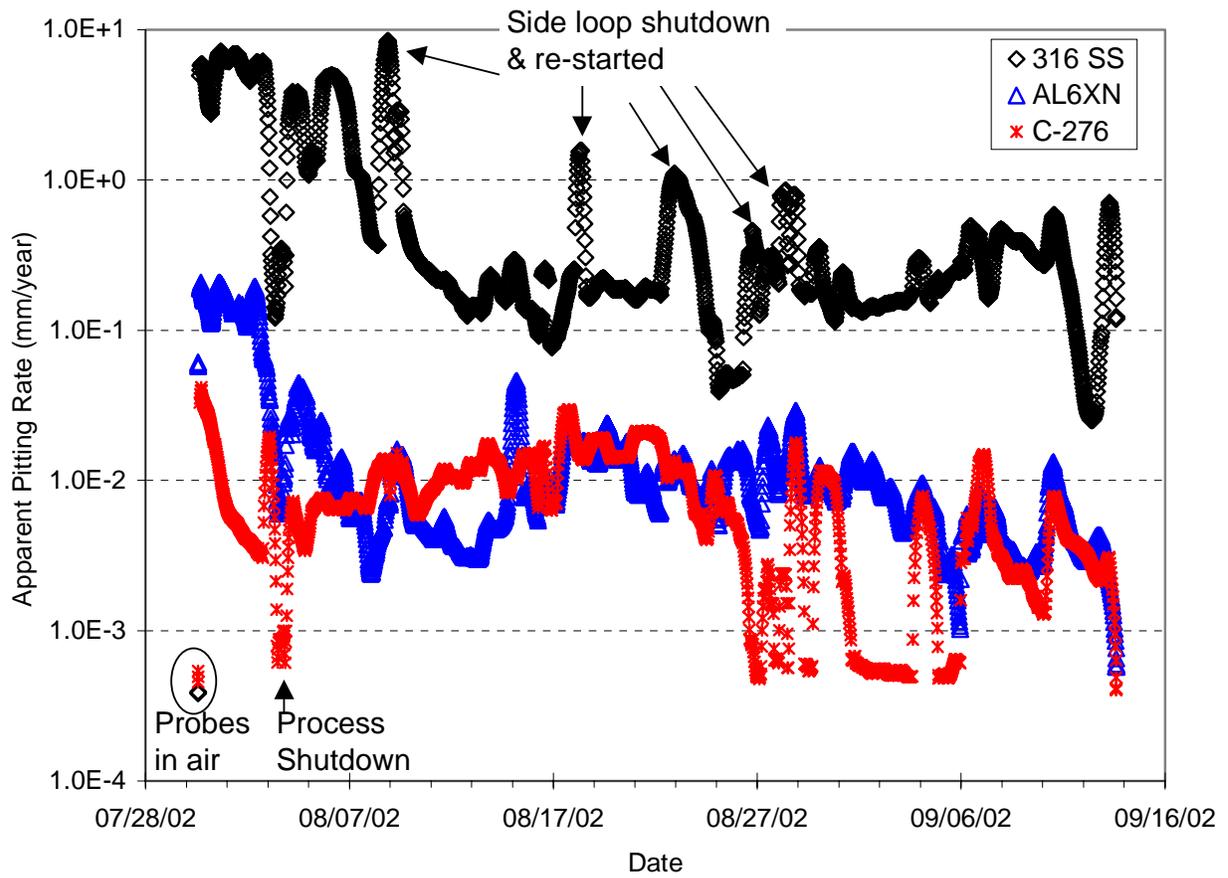
FIGURE 6. Apparent pitting rates from different probes in a side loop of a hot brine process stream during a 45-day monitoring period. Many of the corrosion-rate peaks coincide with the side loop shutdown and start-up, which involved changes in both fluid flow and temperature.

The apparent pitting rates for three different probes obtained in a 45-day monitoring period are presented in Figure 6. After a few weeks of exposure, the apparent pitting rates from all the probes decreased significantly. There were also significant fluctuations in the measured apparent pitting rates. Many of the fluctuations coincided with the short-term shutdown and start-up of the side loop. These shutdown and start-up activities inevitably caused sudden changes in fluid flow dynamics and temperature. The temperature usually dropped to ambient when the side loop was shutdown because it was not heated or insulated. Figure 6 also shows that localized corrosion continued even when the system was shutdown because the process fluid was still in contact with the probes.

At the end of the 45-day exposure, the probes were retrieved from the plant and examined. A dense and uniformly distributed layer of scale covered most surfaces exposed to the system fluid, including the sensing electrodes (Figure 7). There were also small areas where the scale had spalled off. The scale was identified as carbonate using Raman Spectroscopy; it was hard and could not easily be removed from the substrate with a soft brush. Therefore, the decrease in pitting rates as shown in Figure 6 after a few weeks of exposure is suspected to be due to the formation of the scale, as it would hinder mass transport at the electrode surface and thus reduce the pitting rate. On the other hand, if a spalling event took place on one or more electrodes, the pitting rate for the probe would revert to a higher value. Such a spalling event may be triggered by sudden changes in fluid flow or temperature. This is probably why many of the sudden increases in pitting rate for the Type 316 stainless steel probe as shown in Figure 6 overlapped with the start-up events.

represented by the shifts in the corrosion potential toward a more noble state after restart of the process. This is consistent with the apparent pitting rates shown in Figure 6.

The surfaces of the AL6XN and the Alloy C-276 probes did not show significant corrosion under the microscope (Figures 11 and 12). This is consistent with the results in Figure 6, because the calculated apparent cumulative depths for the two probes are less than 3 μm , which is beyond the resolution of the microscope.

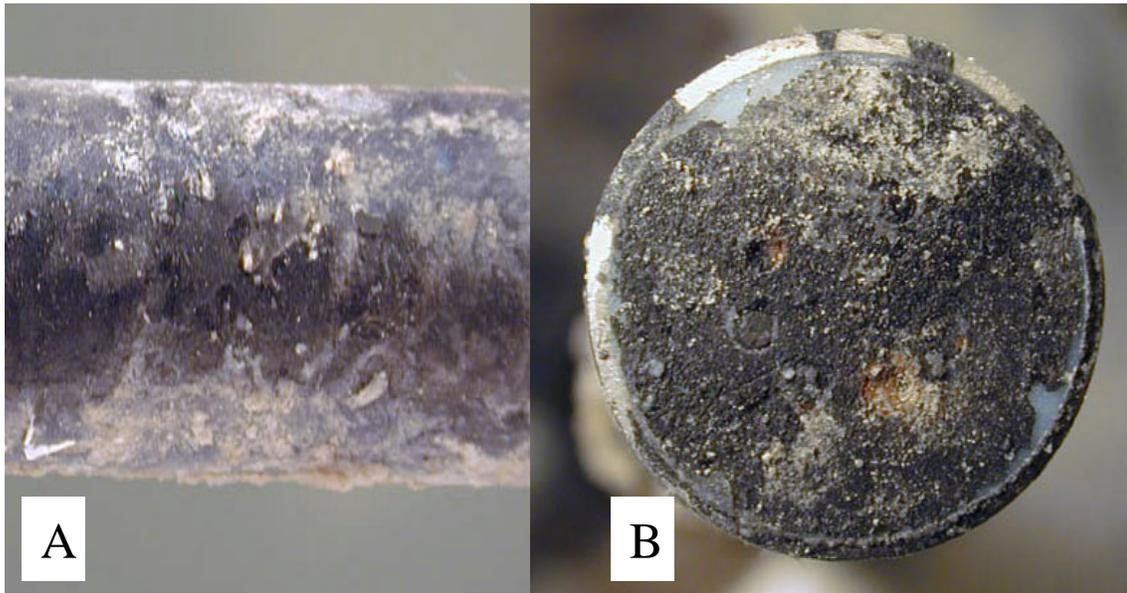
FIGURE 7. Hard and dense scales were typically formed on the side (A) and sensing surface (B) of the monitoring probes after 45-day service in the side loop of a hot brine stream. The black scales were identified as carbonates using Raman Spectroscopy.

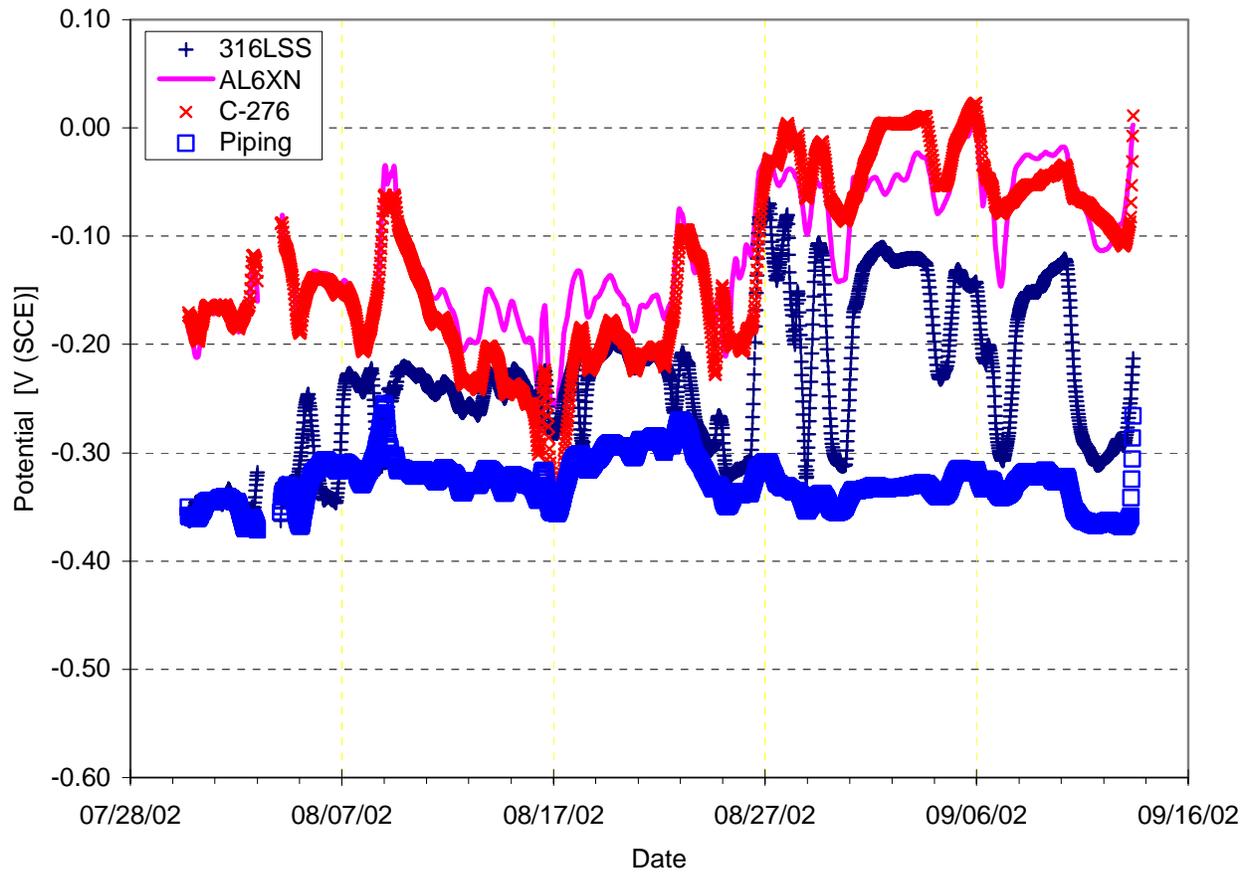
FIGURE 8. Electrochemical potentials of the different probes in and the piping system of the side loop during the time as shown in Figure 6.

Figure 8 shows the electrochemical potentials of the three probes and the system piping during the long-term measurement. The potentials from all the probes increased over time. However, the potential of the piping remained essentially the same. A similar influence of shutdown/start-up activities on corrosion is

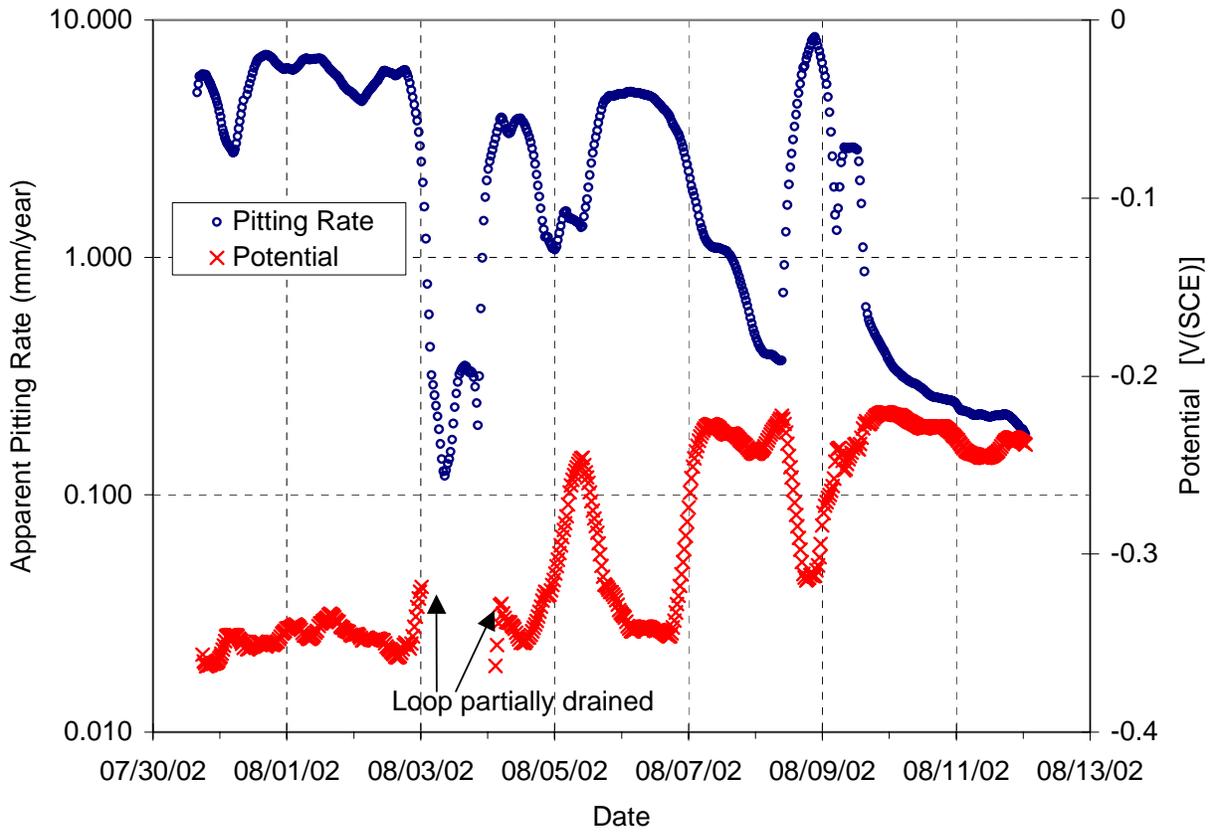
FIGURE 9. Comparison between the apparent pitting rate and potential for the Type 316L stainless steel probe.

Figure 9 shows a typical comparison between the apparent pitting rate and the potential from the Type 316L stainless steel probe. Increases in potential generally overlap with the decreases in the apparent pitting rates or the decreases in corrosion activity.

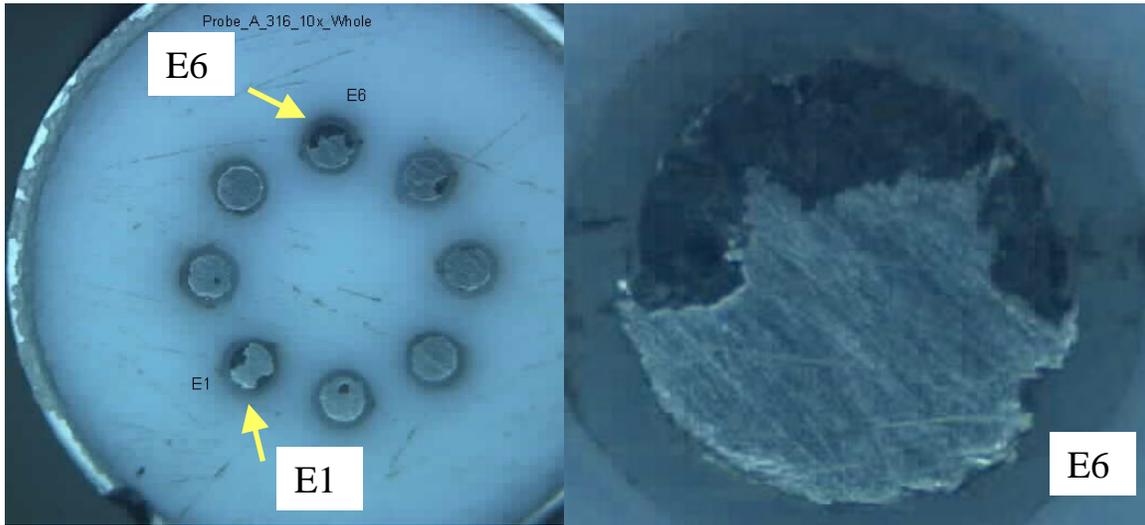
FIGURE 10. The sensing surface of the Type 316L stainless steel probe after 45-day service in the side loop of a hot brine stream. Severe pitting corrosion is apparent on some electrodes.

The electrode surfaces of the different probes were examined using an optical microscope after being cleaned with a hard brush. Some of the electrodes of the Type 316L stainless steel sensor were indeed severely corroded (Figure 10). In Figure 10, about 40% of the sensing surface of the most corroded electrode (electrode E6) were severely pitted and the other 60% were relatively intact. The maximum depth of the pit was found to be about 0.25 mm, which corresponds to an average rate of 2.0 mm/y. The measured average apparent pitting rate for the Type 316L stainless steel probe as shown in Figure 6 is 1.04 mm/year. After accounting for the non-uniform surface factor² (dividing the apparent rate by 0.4 or replacing the apparent surface area with the truly corroded surface area in the calculation of the pitting rate), the modified average pitting rate from the probe during the 45-day monitoring period is 2.6 mm/year, which is close to the actual rate measured after the test (2.0 mm/y).

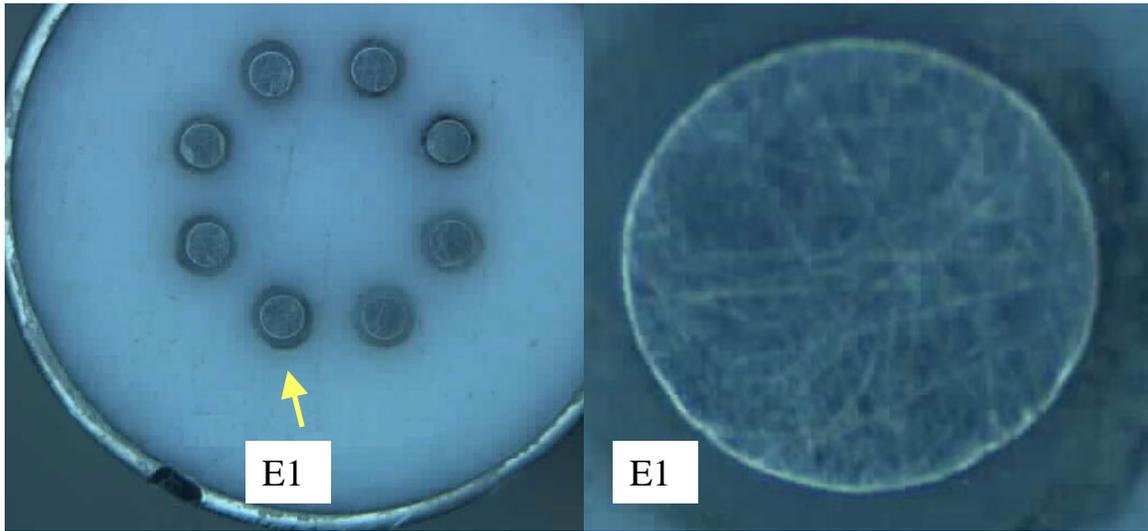
FIGURE 11. The sensing surface of the AL6XN probe after 45-day service in the side loop of a hot brine stream. No apparent pitting corrosion could be visually seen.

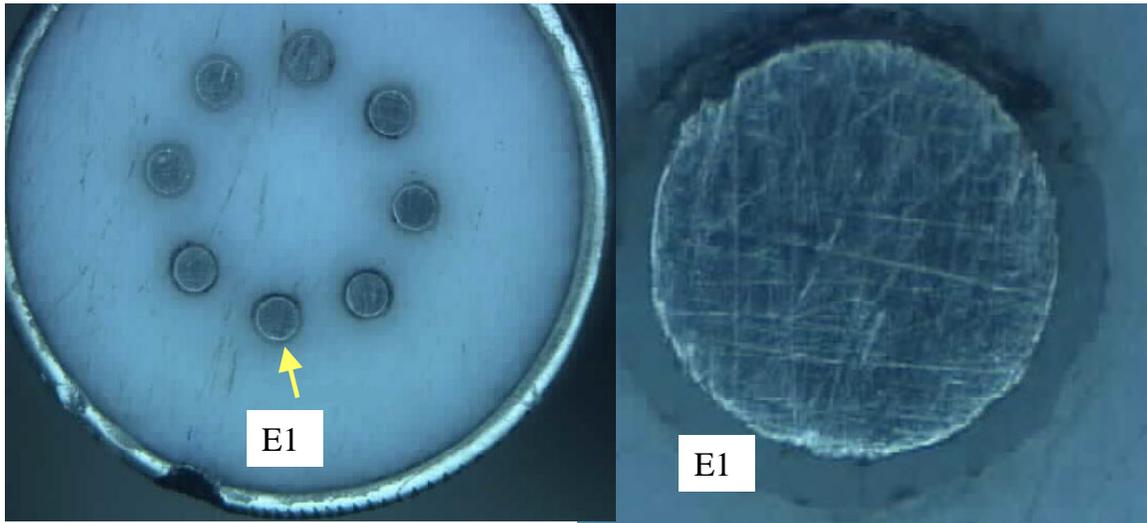
FIGURE 12. The sensing surface of the Alloy C-276 probe after 45-day service in the side loop of a hot brine stream. No apparent pitting corrosion could be visually seen.
